Design strategies for thermal improvements in social housing: Applications in the town of San Lorenzo de Tarapacá, Chile.

Bernardita Devilat and Felipe Lanuza

Master in Architecture Program, School of Architecture
Pontificia Universidad Católica de Chile, Santiago, Chile.

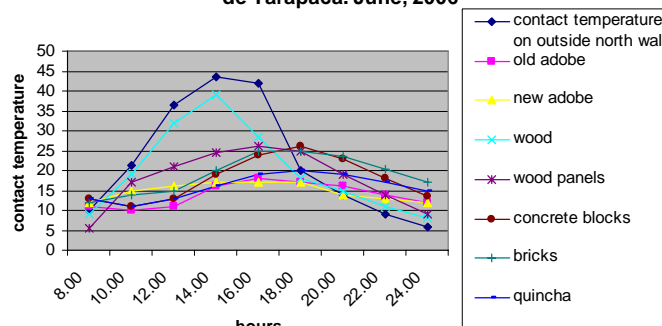
Temperature comparison of chosen cases. San Lorenzo de Tarapacá. June, 2006

Figure 2: Contact temperature comparison of inside north wall in chosen houses. The outside temperature is an average of all cases.

The graph (Fig. 2) shows that the best thermal behaviour is the quincha, because it has the best relation between its situation during day and night. While other materials show a good behaviour only in the day, in *Tarapacá*, quincha and also adobe have the capacity of absorb and release heat, which determines a good behaviour with high and low outside temperature. [7] In this way, the concept of charge and discharge, meaning the process of transferring solar energy when it is needed, appears as an important issue: in *Tarapacá* there is much sun energy during the day that could be used for heat the interior in the night, when the temperature decreases.

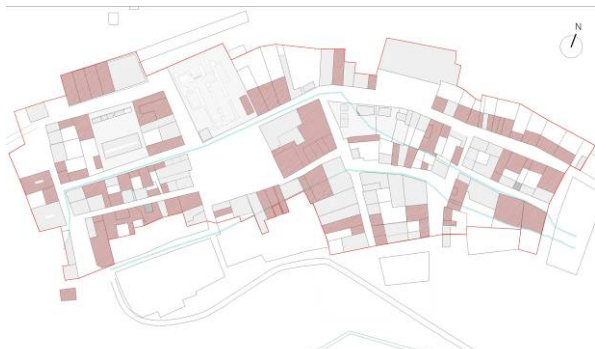
Figure 3: Plan of San Lorenzo de Tarapacá zoning by earthquake damages. The dark red sites are the ones for been re-built and the gray ones are those for been restored.

From the study of the village after the earthquake of 2005, it was identified three types of buildings. (Fig. 3) In first place, the ones that are without damages. In second place, the buildings that have particular conditions so they have to be restored. In third place, the sites that it is necessary to re-built because of their damage level. The proposal is focussed in the last ones, because its reconstruction will allow to re-configure the continuous façade and to shape the public space of town.

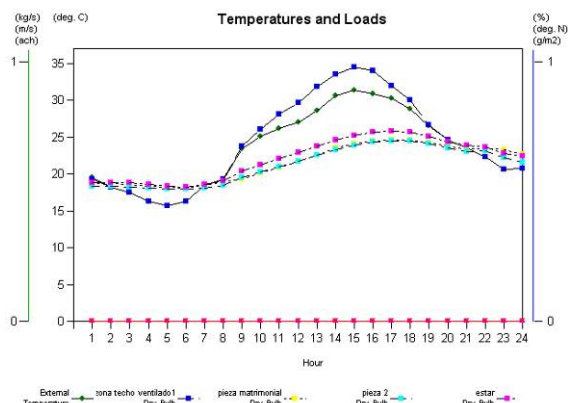
Figure 6: North façade proposal on day 59

Both models works properly, because their building elements equilibrate the inside temperature using the heat of the day. (Fig. 6, 7, 8, 9) However, the north model has low inside temperatures than

The graphs shows that the first model works better isolating from the heat, produced by direct solar radiation, rather than warming at night with the stored heat. The larger room has the better thermal performance, maybe because it has the larger area of the north adobe wall that receives direct sunlight. However, it was tested the same model with all adobe walls, and the behaviour was practically the same. This indicates that there is no necessity to build all walls with 60 cm of thermal mass (adobe) thickness, but only those that are receiving solar radiation.

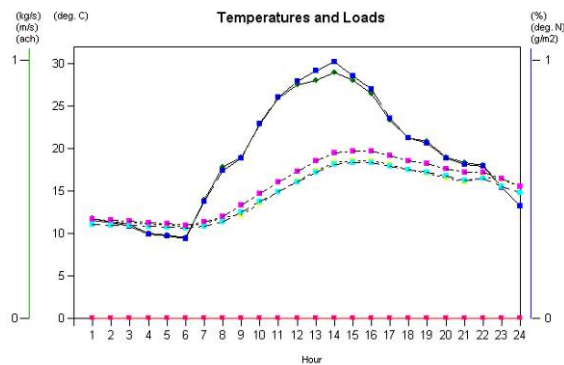
Figure 7: North façade proposal on day 200

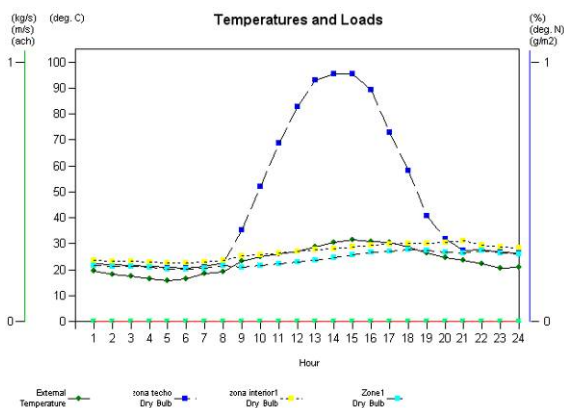
Figure 8: South façade proposal on day 59

The second model shows an air camera that storage heat in day and liberates in night in a most efficient way than the other model. This element could storage a great volume of heated air, at least enough for all night. Even when this proposal seems to be better for the temperature oscillation problem, during day it presents a small overheating situation. However, this problem can be solved by using more isolation in the elements that are in contact with the air heated camera.

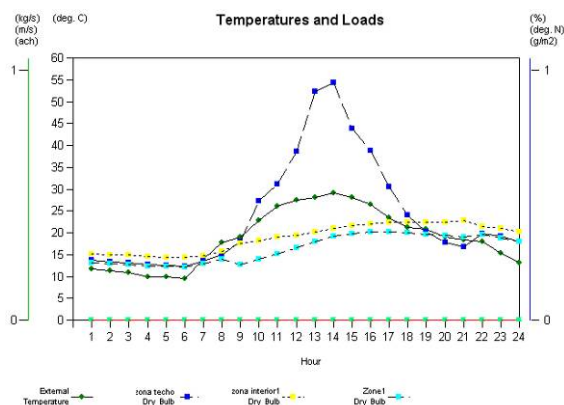
Figure 9: South façade proposal on day 200
